Inspection Advantage Comparison: Array Inspection Solutions

Comprehensive Detection Capabilities for Balance of Plant Heat Exchanger Applications

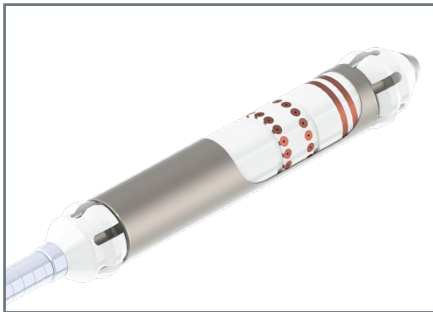
Zetec CXB4 array probe for heat exchanger tubing inspections

Both array probes in this evaluation had the same diameter and incorporate bobbin and array coils intended to find and characterize axial and circumferential flaws. The Zetec CXB4 probe has two rows of 19 coils each which act as driver and pickup coils in a robust body. The competing probe has two rows of 14 coils each.

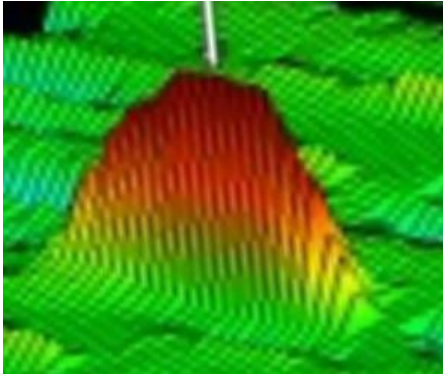
Zetec 20% ID Axial

2. The Zetec System Detected All ID and OD Flaws: The 20% EDM notches were utilized for this comparison as they are the smallest EDM notches in the standard. The Zetec system easily detected all four 20% EDM notches in axial and circumferential orientations. The competing system was able to detect the axial and circumferential OD notches but did not detect the axial and circumferential ID notches as shown in the areas circled and indicated in red:

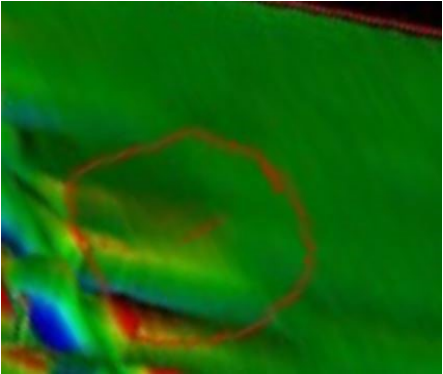
Competitor 20% ID Axial

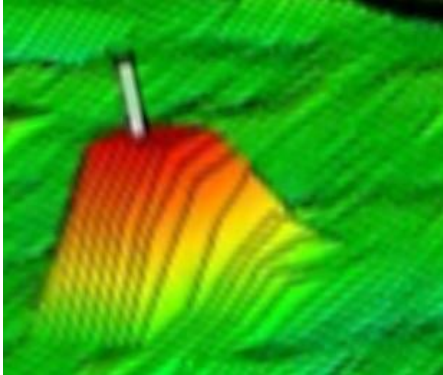
Zetec 20% ID Circumferential

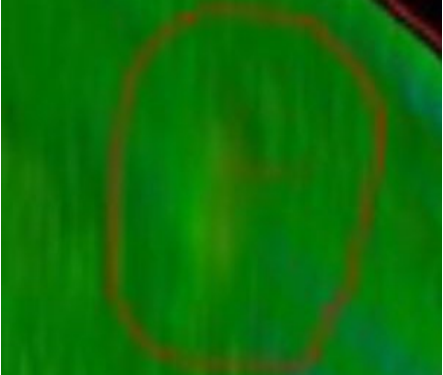
Competitor 20% ID Circumferential
